Inspection Report

Minerals Regulatory Program

May 20, 2015

Mine Name: Anval 1&2 Mine	Permit Number: S/001/0038
Operator Name: Steven Gale	Inspection Date: May 12, 2015
Inspector(s): Peter Brinton	Time: early afternoon
Other Participants: none	Mine Status: Reclaimed

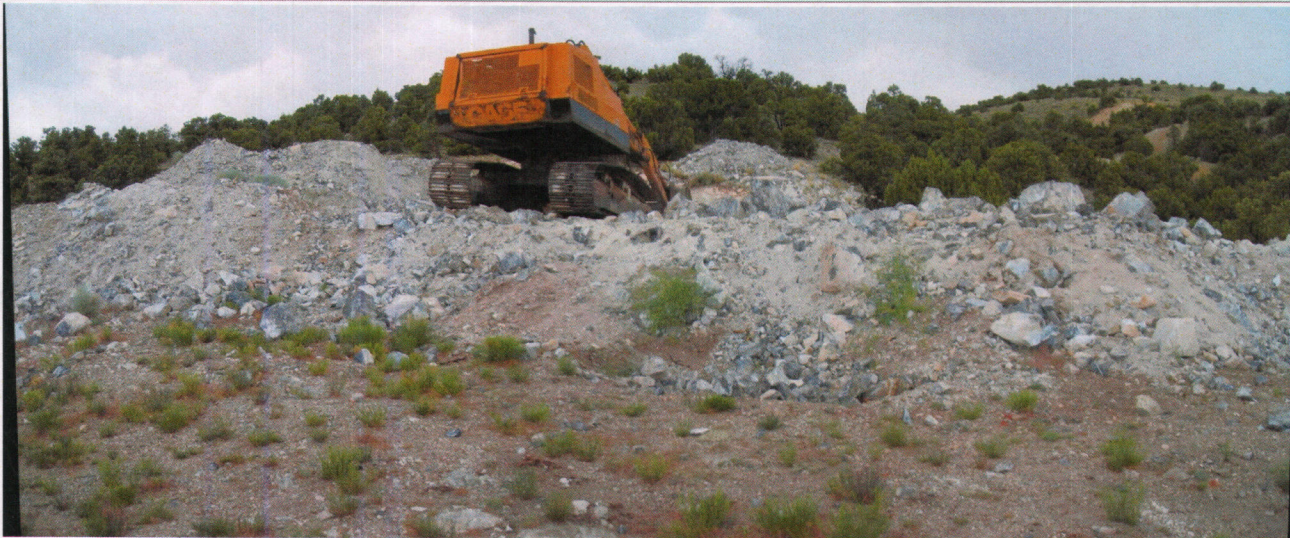
Active mine disturbance. Stitched photos. (Photos taken June 6, 2007).

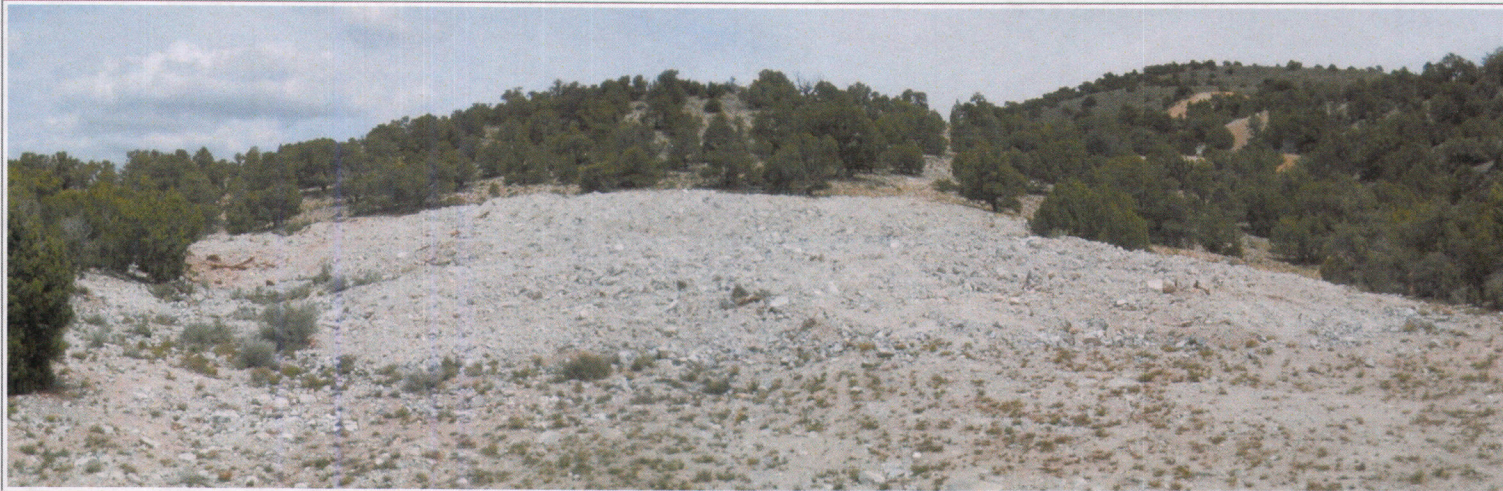
Inspection Summary: The site had been regraded, and reclamation earthwork is acceptable. The operator did a nice job of grading the site to fit in with the natural contours, and no rock faces or pits remain. The excavator was taken off-site, and no trash was visible. No significant safety hazards remain. The graded surface was left rough, and it is unlikely that any notable erosion will occur. Apparently no soil was saved. Adjacent areas of what appear to be past reclamation are successfully vegetated with rabbitbrush, a little grass, and other natives with relatively few weeds, and the lack of topsoil replacement is not expected to be the driving factor in revegetation success or failure. Not much of a soil has developed here. Ed Ginouves (BLM-Cedar City) reported spreading crested wheatgrass seed on the regraded site within a few days. At the time of my inspection, no seedlings were visible. Recent storms may or may not have changed that. Surrounding areas are a mix of junipers, rabbitbrush, native grasses, other natives (perhaps a snakeweed), and some weeds (none of the noxious variety were seen).

Regraded mine disturbance. Stitched photos. Note the dry drainage area on the left with no defined flow path. (Photos taken May 12, 2015).

Conclusions and Recommendations: The site was regraded and meets reclamation standards. It is recommended that the reclamation bond be partially released, and that some reclamation bond be retained to cover revegetation.

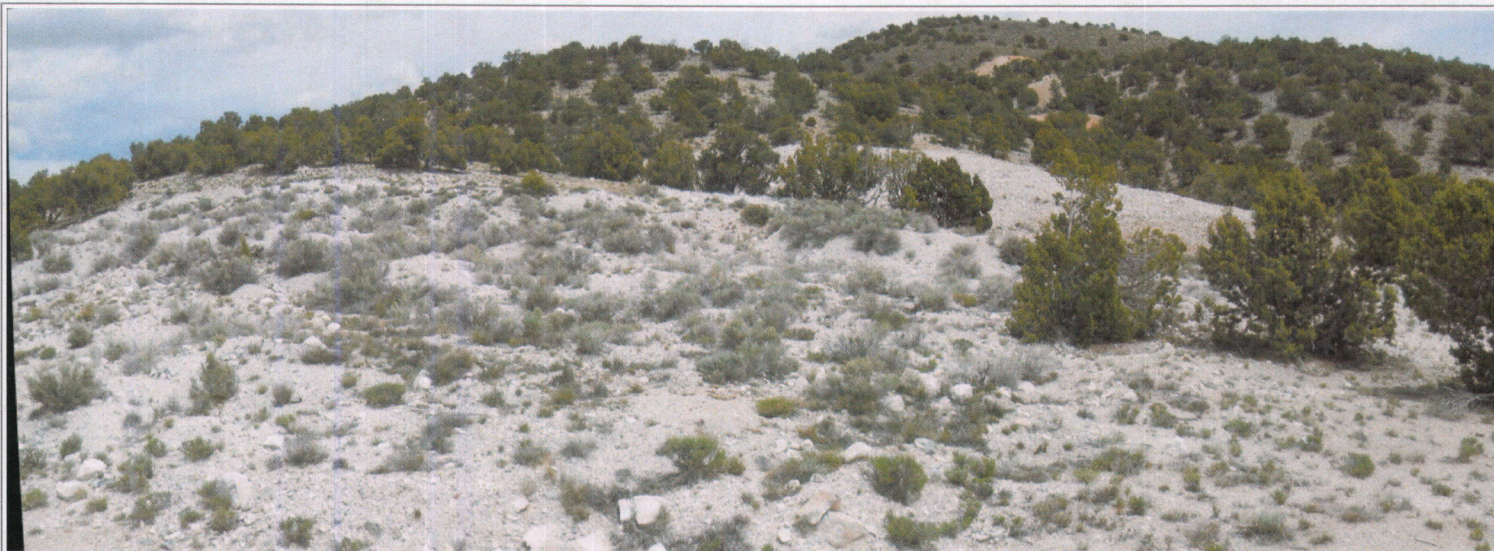
Area west of the regraded disturbance with successful revegetation. The recently graded site is behind and to the left. (Stitched photos taken May 12, 2015).

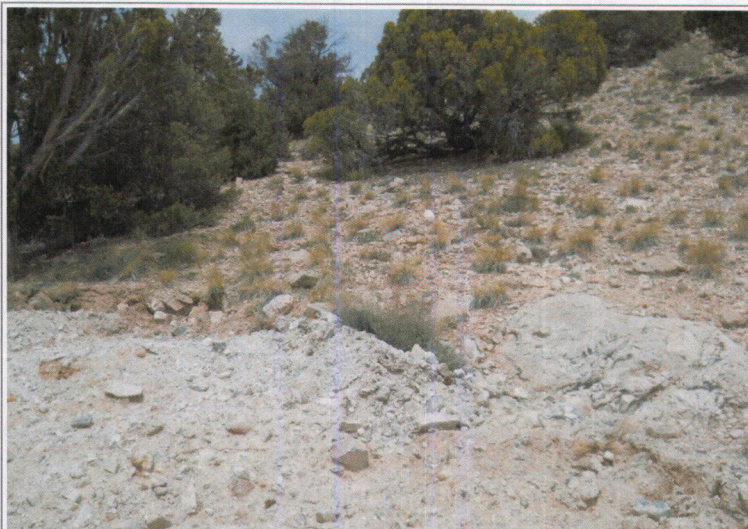
Undisturbed area upslope of graded disturbance. (Photo taken May 12, 2015).

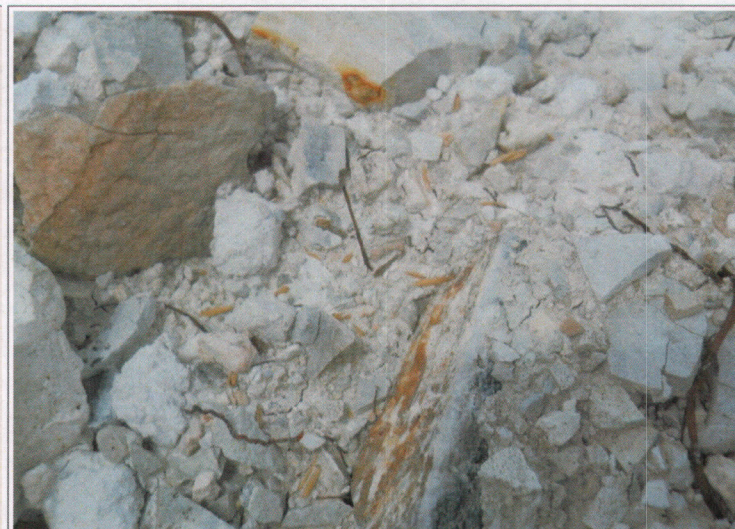
Seed spread by Ed Ginouves, BLM. (Photo taken May 12, 2015).
